Final Report

TECHNICAL COMMITTEE FOR INSPECTION OF THREE BREACHED TANKS IN BBMP LIMITS AND FOR SUGGESTIONS TO PREVENT FURTHER SUCH INCIDENTS.

Ref: G.O. No.: UDD 250 MNY 2018 (Part-1), Bengaluru dated 2nd December 2019.

Report of the Technical Committee for inspection of three breached tanks
in BBMP limits and for suggestions to prevent further such incidents.

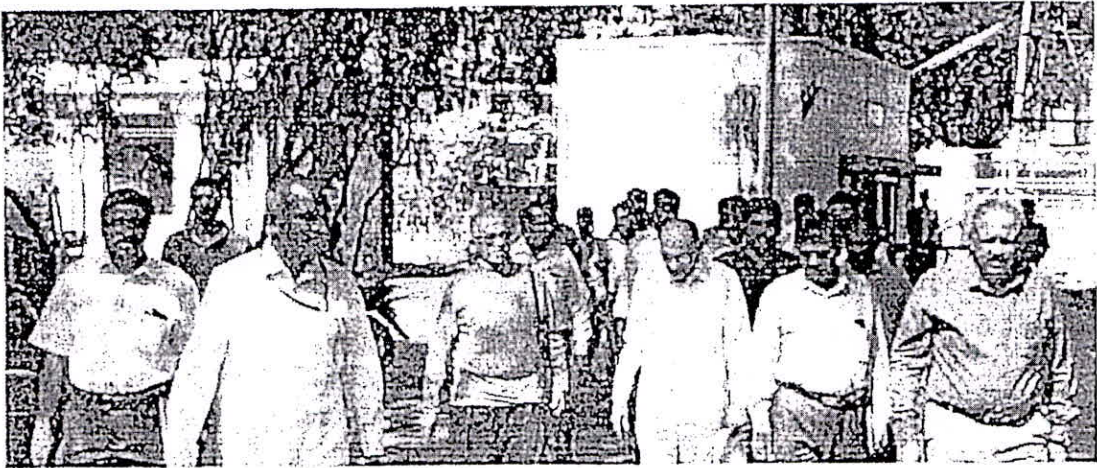
Photo-2(a) – Inspection of Doddabidarakallu tank by Technical Committee with officers

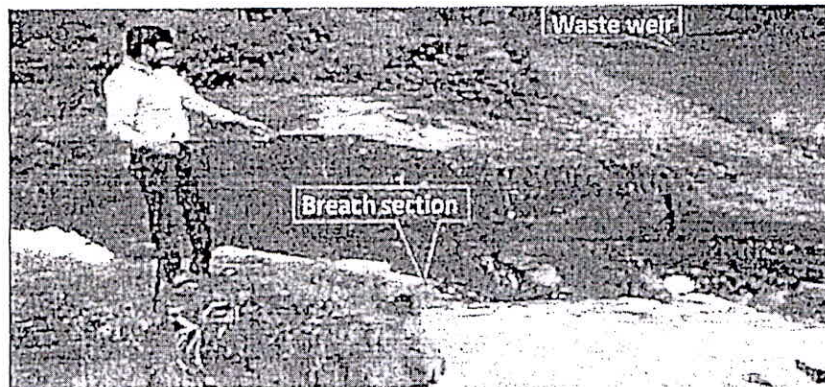
- iii) **The breach in the Doddabidarakallu tank bund is attributable to inadequate compaction of embankment near the sluice after the insertion of pipes and improper closure of pipe insertion in the bund near the sluice aggravated by heavy rains and floating weeds obstructing the water flow over the weir.**

Photo-2(b) – View of Doddabidarakallu weir and the breach section

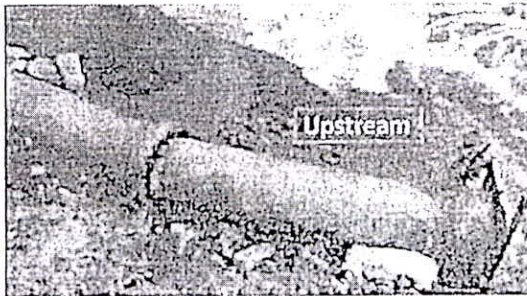
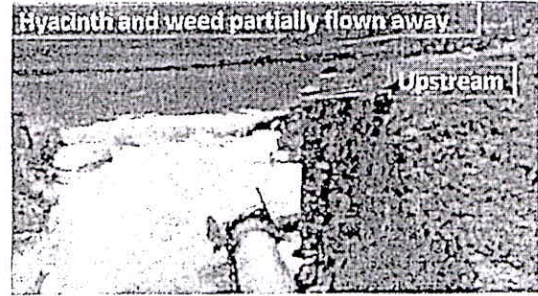
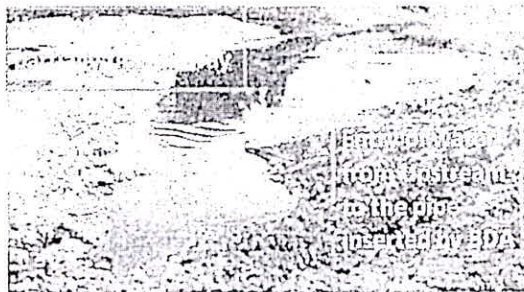
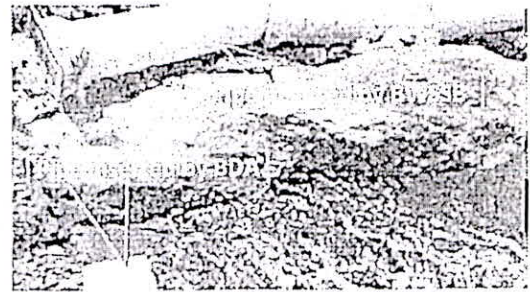
Photo-2(c) & 2(d) – View of pipes inserted in the breach section near sluice

Photo-2(e) & 2(f) – View of pipes inserted in the breach section near sluice

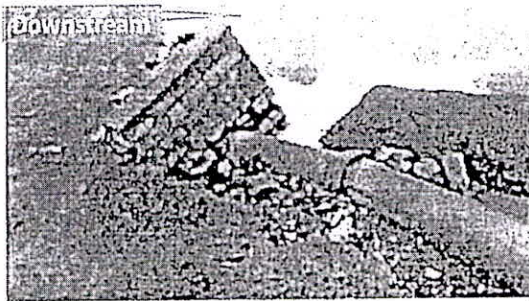
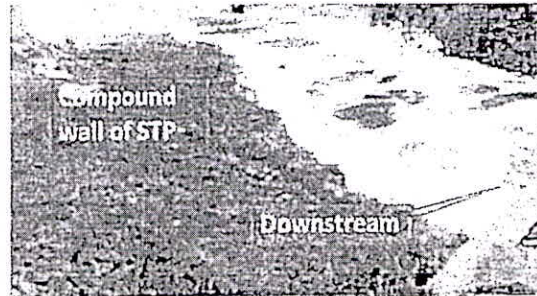
Photo-2(g) & 2(h) – View of pipes inserted in the breach section near sluice and the flooding down of water in the sluice nala next to the compound wall of STP

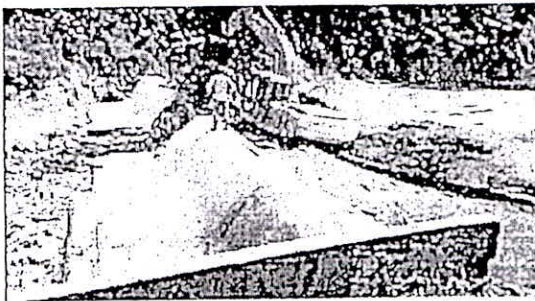
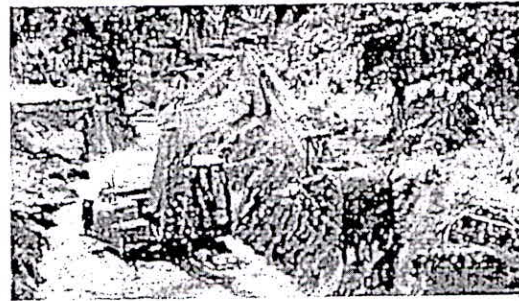
Photo-2(i) & 2(j) – After the breach - Breaking of weir to allow water in raja kalue and widening of raja kalue

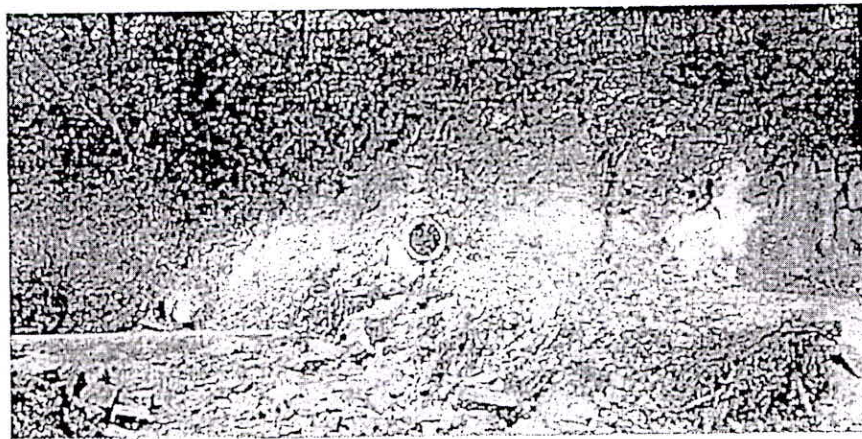
Photo-2(k) Encroachment of weir and illegal insertion of pipes to drain into tank

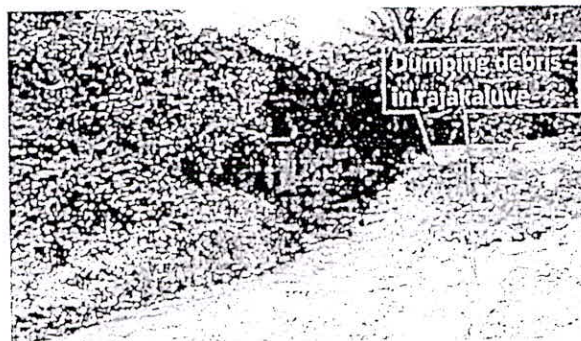
Photo-2(l) Encroachment of rajakaluve by dumping debris

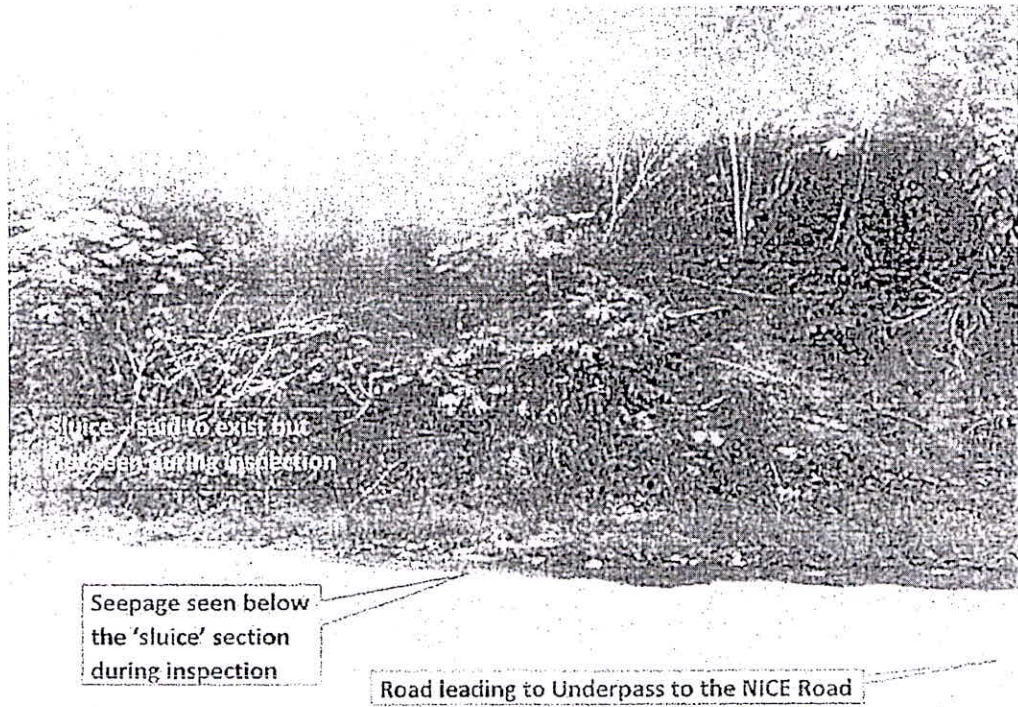
Photo-3(a) – Hosakerehalli tank bund outside view near the sluice

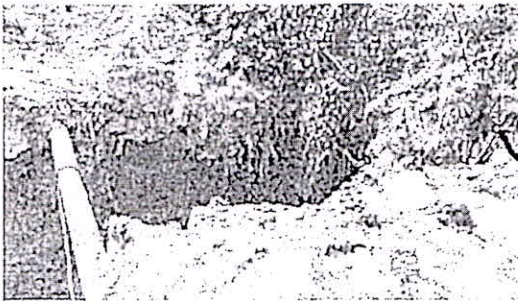
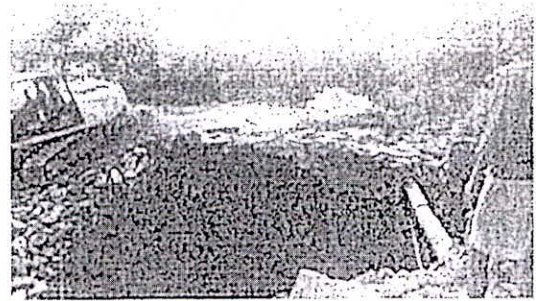
- iv) The breach in the Hosakerehalli tank bund is attributable to inadequate compaction of embankment near the sluice after the insertion of pipes and improper closing of pipe inserted in the bund near the sluice aggravated by heavy rains and the blockage in the raja kaluve downstream of the surplus weir.**

Photo-3(b) & 3(c) – Hosakerehalli tank- View of breach section

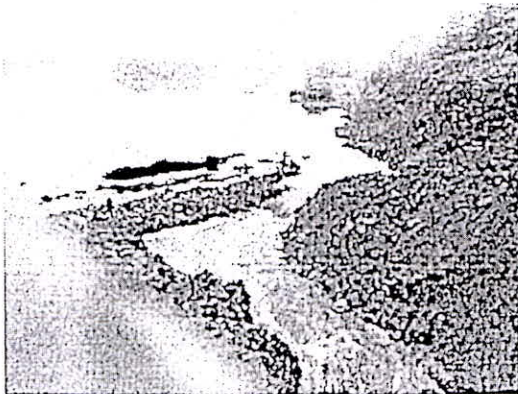
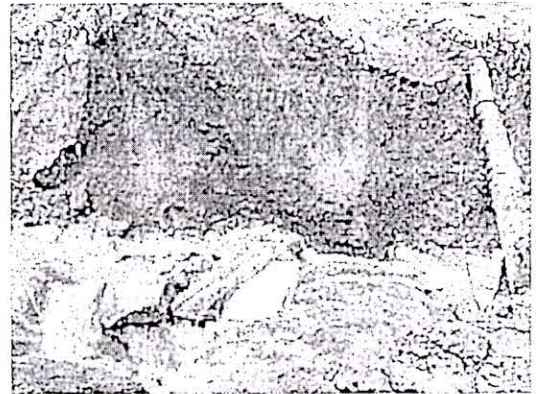
Photo-3(d) & 3(e) – Hosakerehalli tank- Reconstruction of breach section

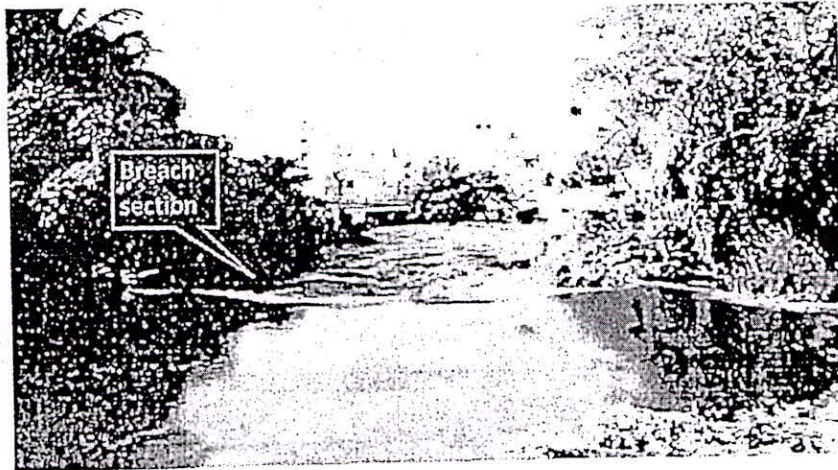
iv) **The breach of the Hulimavu tank bund is attributable to the action of lowering the earthen bund due to ignorance of the consequences of water flow at a place other than the weir. This action has triggered gradual erosion of soil from the embankment and the increasing flow of water has resulted in the breach of bund.**

Photo-4(a) – Hulimavu tank bund breach

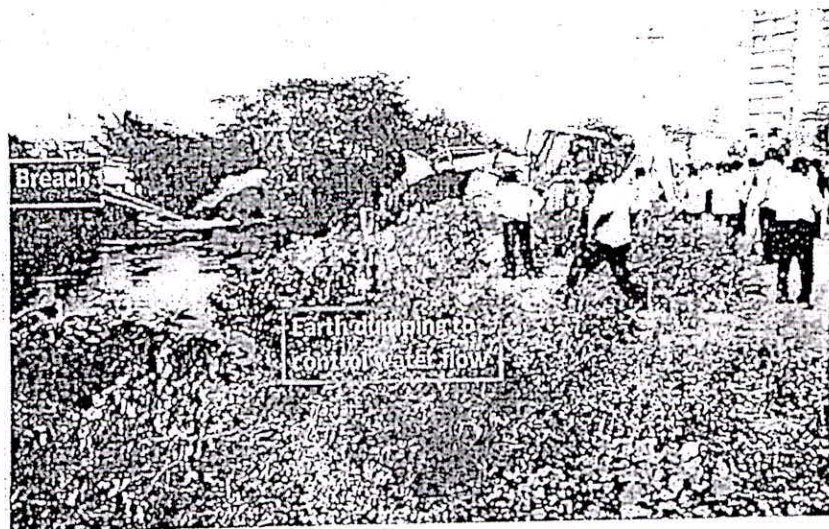
Photo-4(b) – Hulimavu tank bund breach controlling

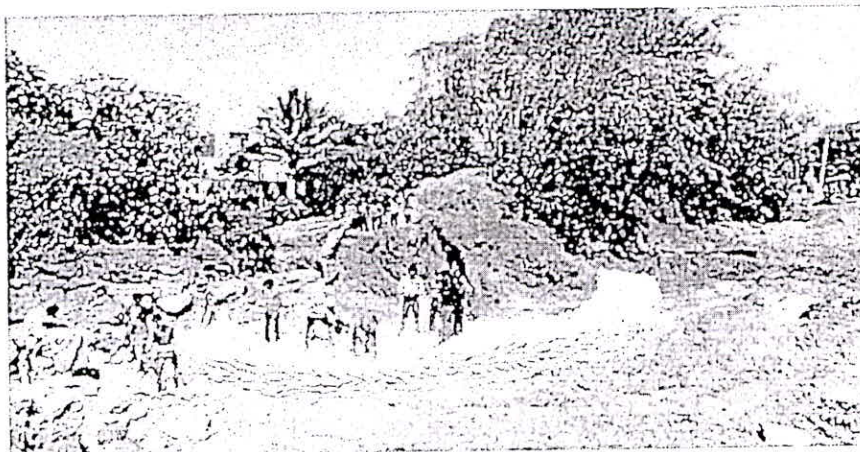
Photo-4(c) – Hulimavu tank bund restoration work after the breach

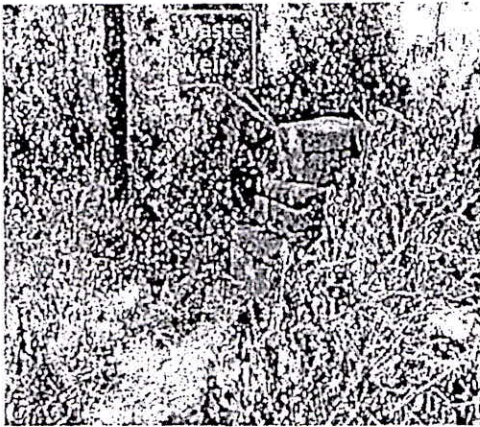
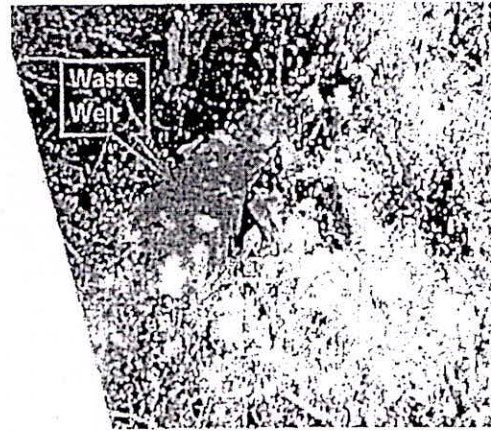
Photo 5 (a) & 5(b)- Waste weir of Singapura tank is neglected as road is formed after the weir in the downstream raja kaluve

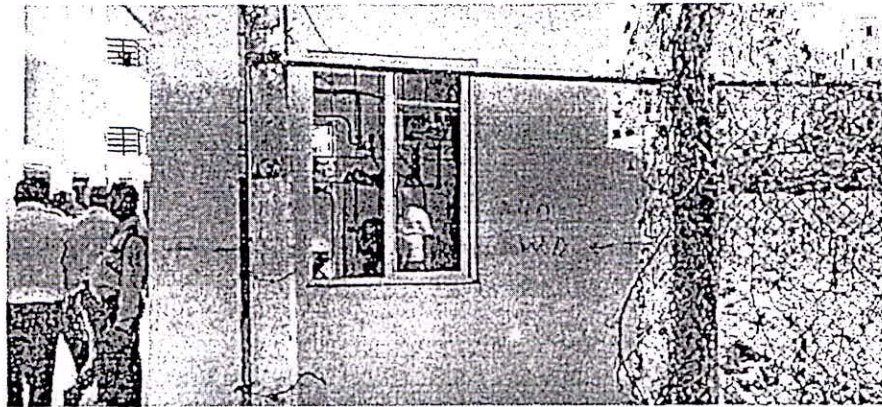
Photo 5 (c) – Encroachment of nala down the sluice of Singapura tank

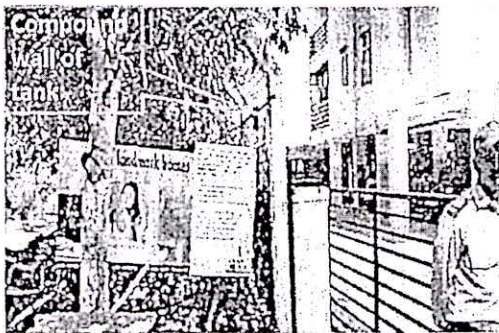
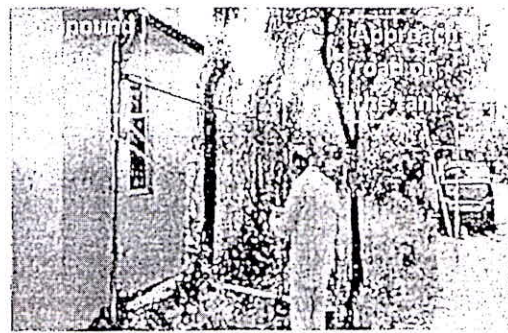
Photo 5 (d) – Encroachment of tank bund for formation of approach road

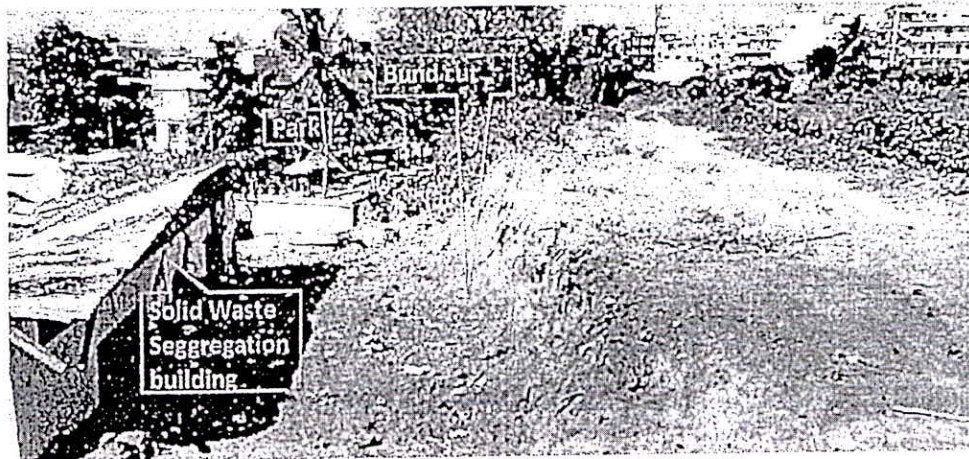
Photo 6(a) – Bund of Gowdanapalya tank cut and width diminished to accommodate a building for Solid waste segregation and further to accommodate Storm Water Drain

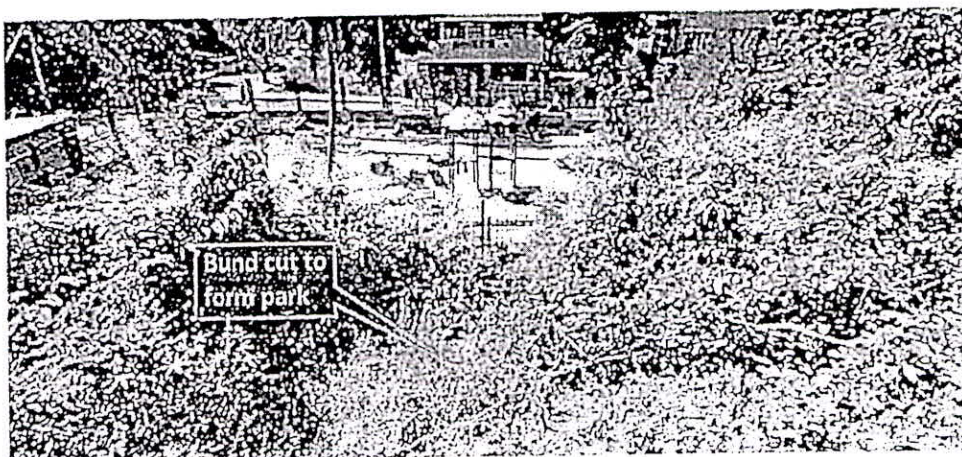
Photo 6(b) – Bund of Gowdanapalya tank cut to develop a park

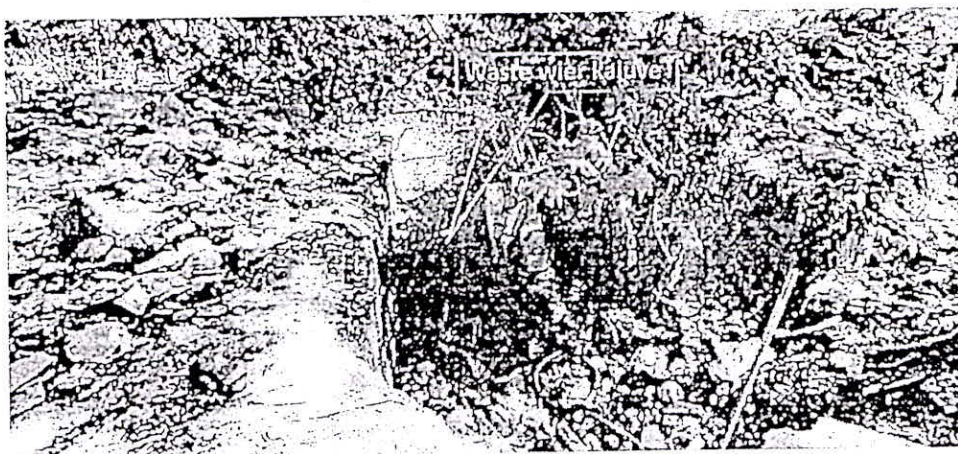
Photo 6(c)- Waste weir of Gowdanapalya tank almost closed with debris thrown-in

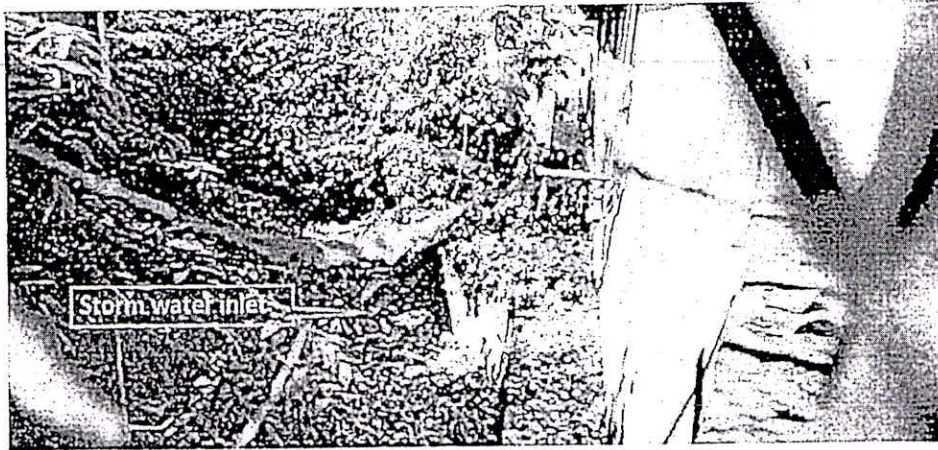
Photo 6(d) - Inlet of Gowdanapalya tank is completely choked with debris and Storm Water diversion work is taken up

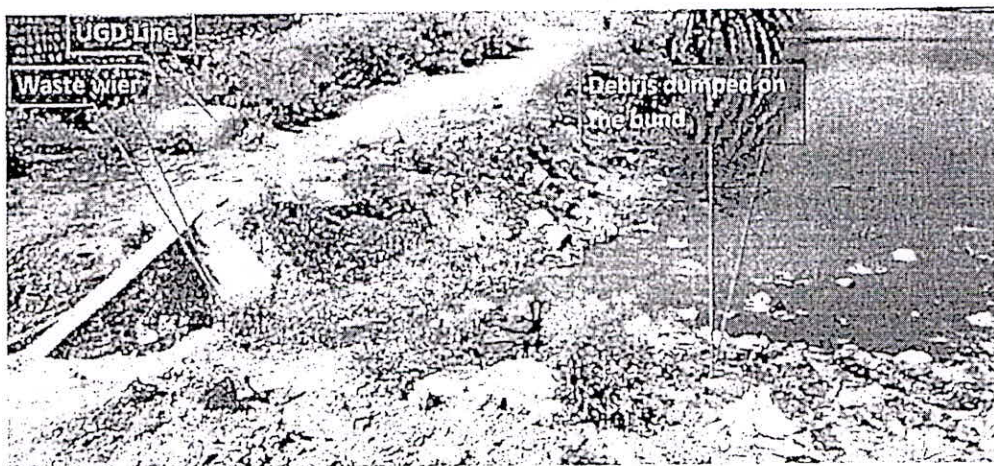
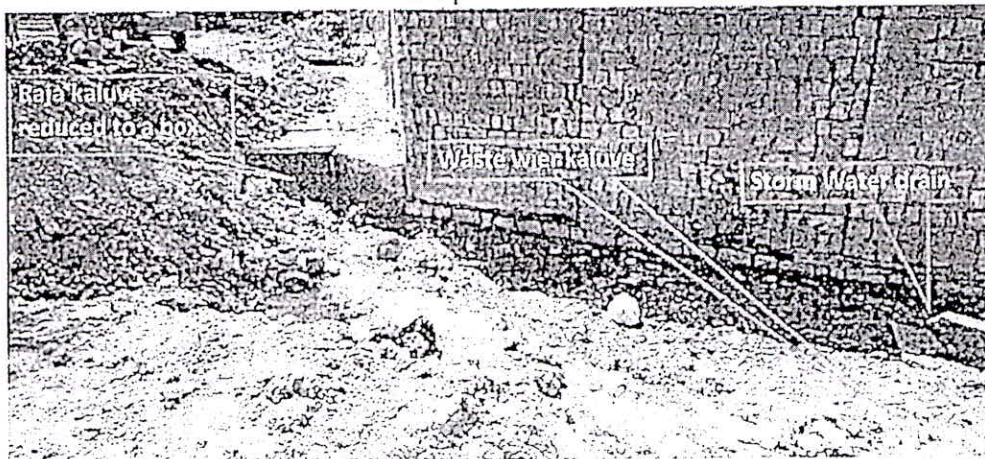
Photo 7(a) above & 7(b) below – Waste weir of Kelaginakere Bairasandra tank is completely encroached with debris. UGD lines are carried in the tank bund. Tank bund is encroached by filling the debris. Storm water drain is being constructed by the side of compound wall.

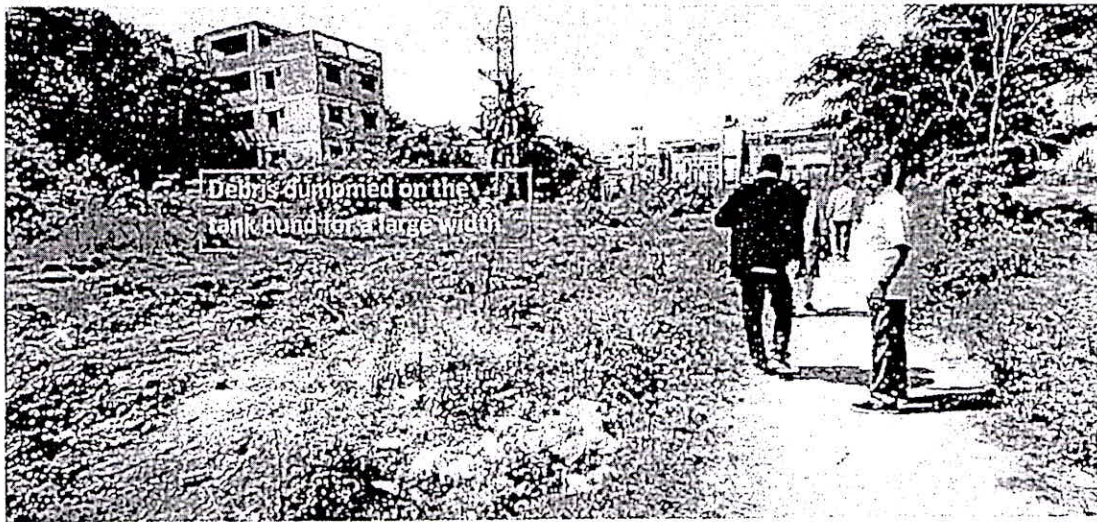
Photo 7(c) – Encroachment of Kelaginakere Bairasandra tank by dumping debris

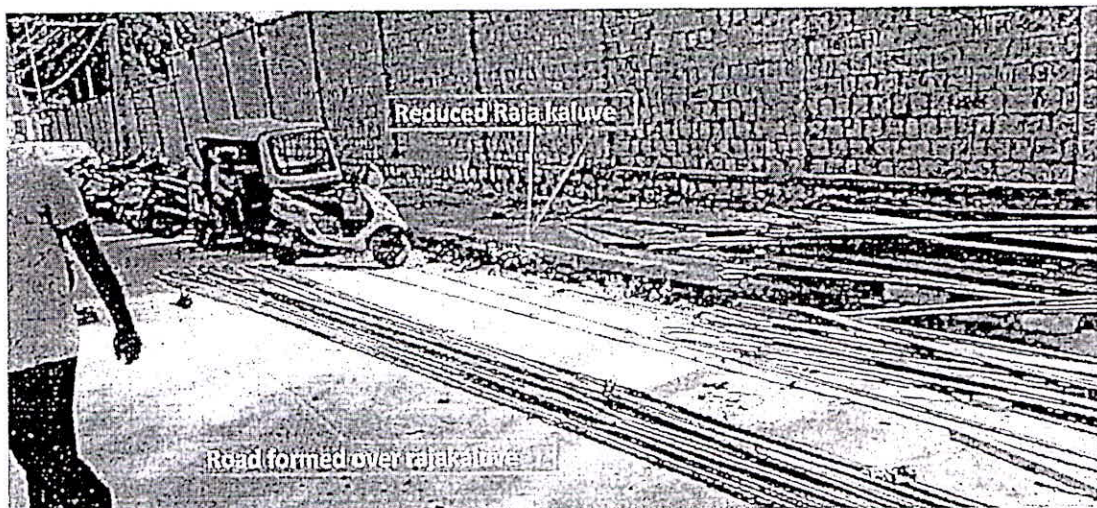
Photo 7(d) – Raja kaluve of Kelaginakere Bairasandra tank is reduced to a box drain of small section and a road is formed encroaching it.

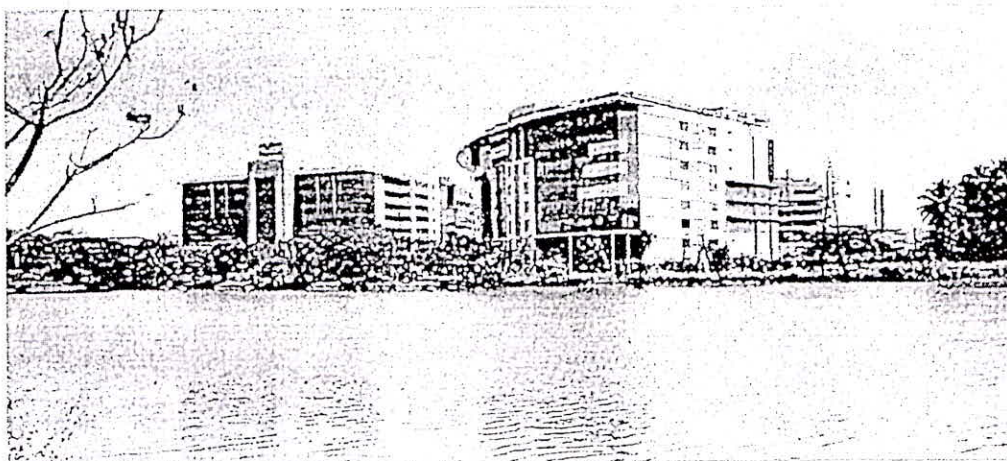
Photo 7(e) – Encroachment of Kelaginakere Bairasandra tank bund

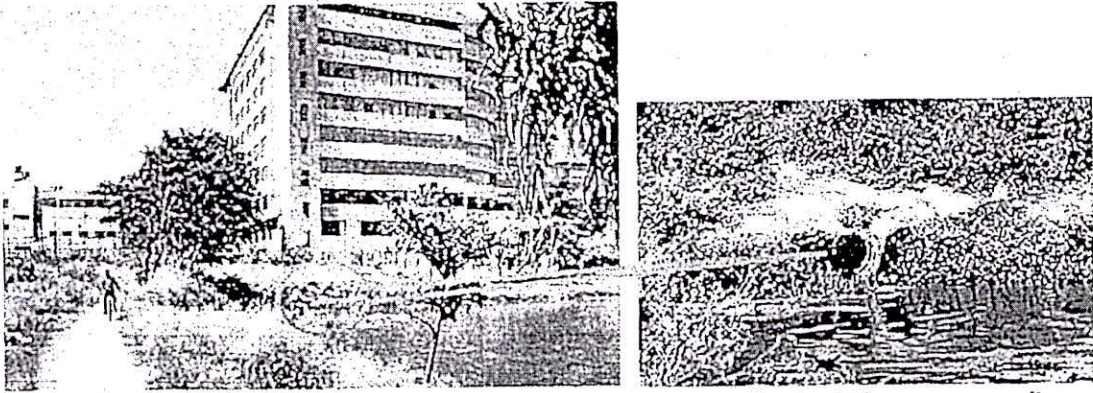
Photo 7(f) – Sewage water let into Kelaginakere Bairasandra tank from surrounding buildings

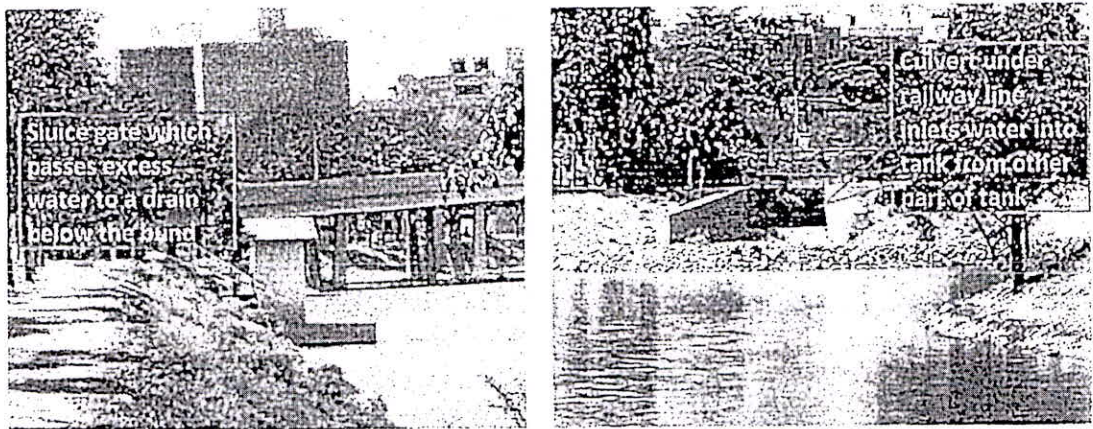
Photo 8(a) & 8(b) – Sluice and Inlet of Benniganahalli tank near K.R.Puram. There is no waste weir. It is divided into tanks by passing of a railway line. The other part of the tank is non accessible as it is surrounded by 3 railway lines in triangular pattern. Surplus water from that part of tank can pass off through the culvert under railway line.

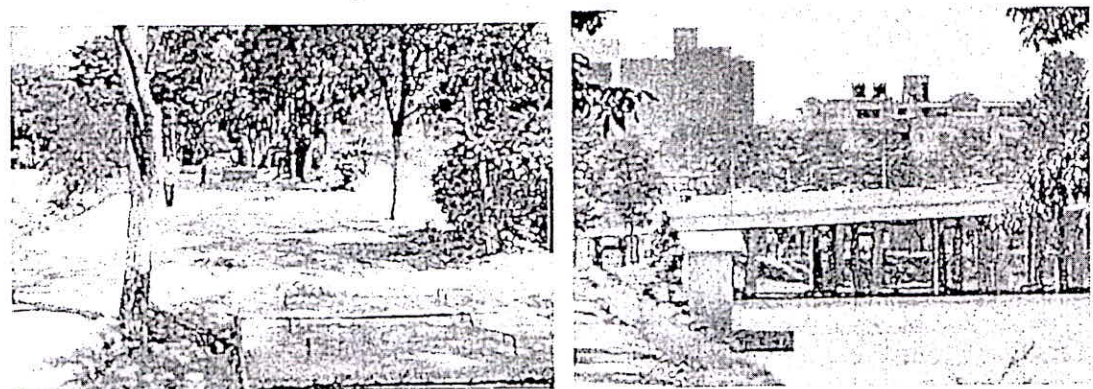
Photo 8(c) & 8(d) – Storm water line and chambers seen in the bund. Right side Flyover constructed in inside the tank. It was informed that it is proposed by BMRCL to reduce the bund width by constructing diaphragm wall in the bund and cutting off the outer part of bund to expand the road way below the tank in order to carry the Metro line in between the roadway.

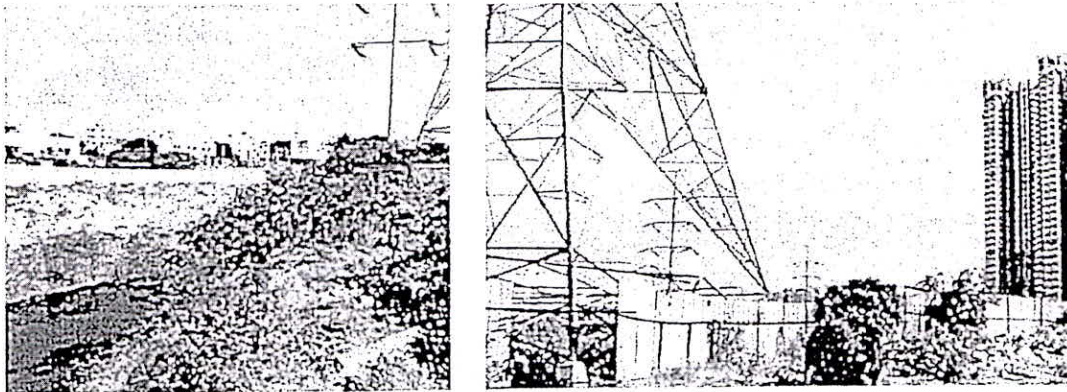
Photo 9 - Rajakaluve of Bhattarahalli tank is encroached and compound wall is constructed surrounding it by a builder

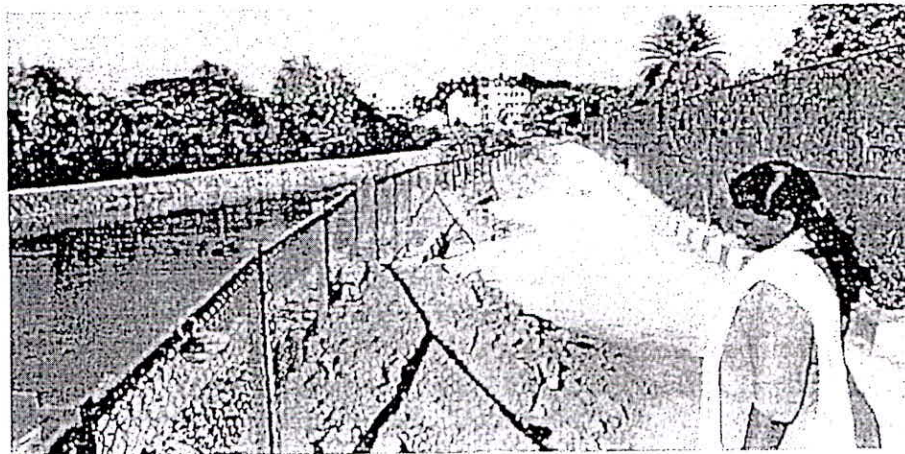
Photo 10 – Work being carried out in Kalkere tank bund independently by Horticulture without coordination with Lakes Division of BBMP

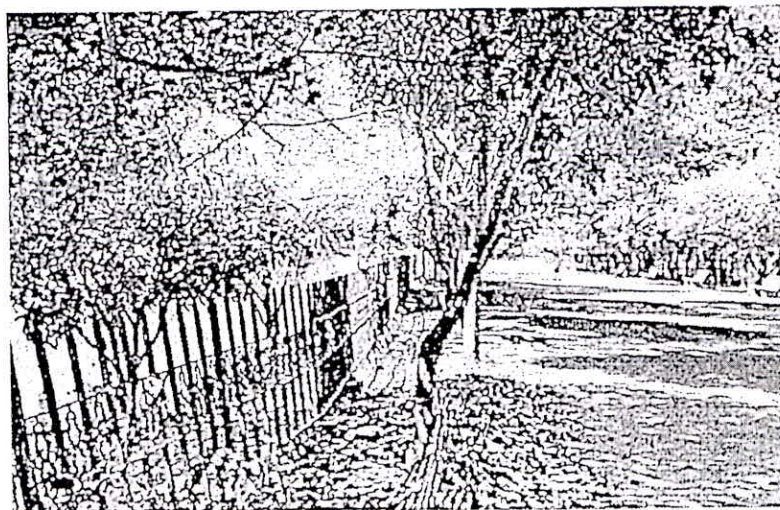
Photo 11- Tree planting and park development on the bund of Dorekere independently under Corporators' Fund and by a NGO without coordination with Lakes Division

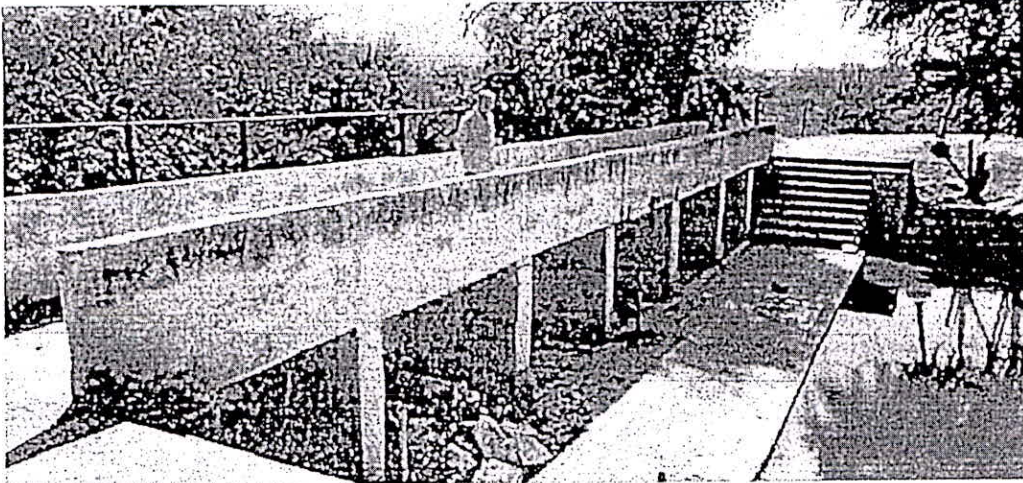
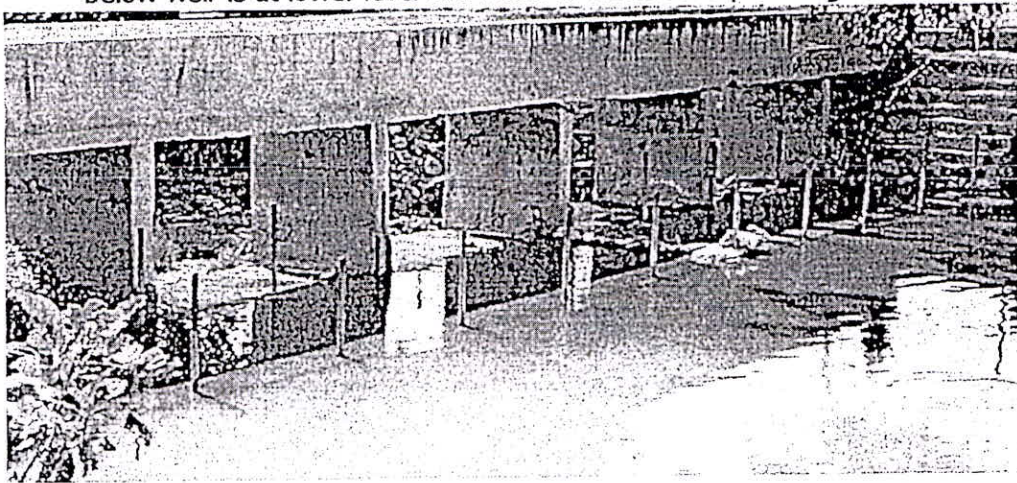
Photo 12(a) above and 12(b) below: Waste weir of Rachenahalli tank at two different levels. The above weir is at higher level and waste is being dumped surrounding it. The below weir is at lower level and water is continuously flowing over it.

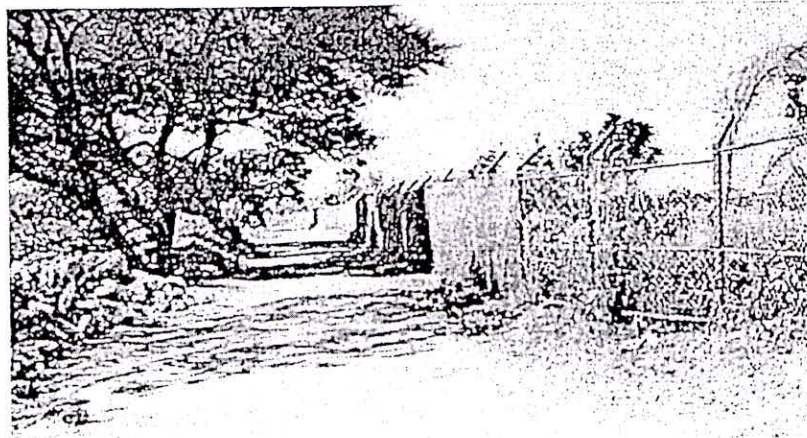
Photo 13- Doddabommasandra tank bund getting extended by the dumping of debris and in due course it has become a new road by the side of the tank.
