**Report of Investigation of issues
highlighted in the VIP Reference**

**No. 56M(HI)/VIP/2024 dated
03.09.2024**

**Regional Office – Bengaluru
Ministry of Environment Forest and
Climate Change**

February 2025

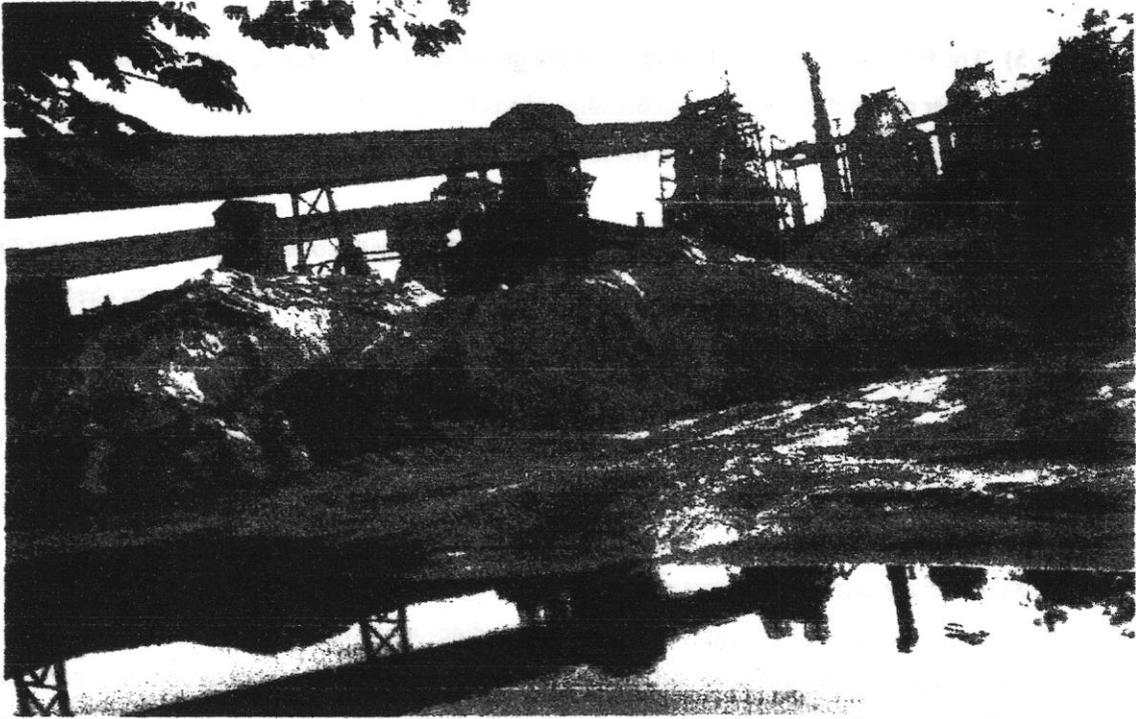
Photo 12. Solid waste storage and housekeeping condition within the industry premises.

- 5) The PP shall scientifically dispose of the generated slag as soon as possible. until then, keep it under covered storage on a stable impervious floor. A logbook of generation versus disposal of slag shall be maintained and made available to the Board Officers during their visits to the factory.

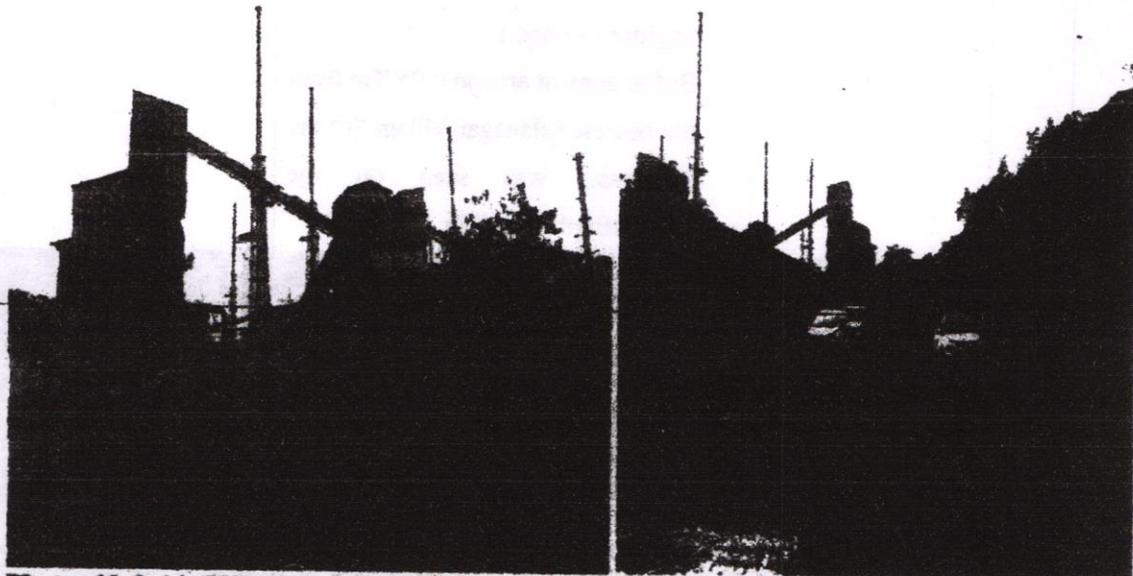
Photos 13 & 14. Glimpses of the industry and the internal road condition.

- 1) Maintenance of equipment, facilities and infrastructure, including the internal roads on a regular basis is strictly recommended.
- 2) The raw materials shall be stored in sheds or under covered storage, on a stable impervious floor.
- 3) Internal roads to be dedusted regularly by deploying suitable road sweeping equipment.
- 4) The efficiency of the air pollution control devices like ESPs/ bag filters shall be examined on priority basis. The report of examination shall be made available to the Board Officers during their visits to the factory.
- 5) To meet the prescribed environmental standards, the PP may come up with a robust action plan in consultation with the KSPCB.

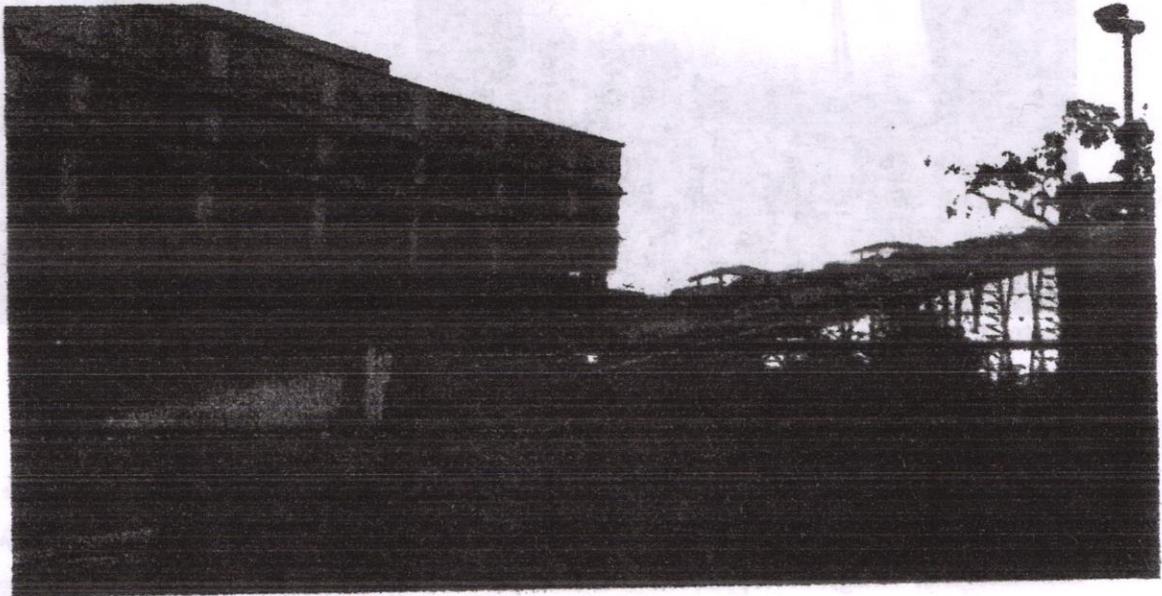
Photo 24. Housekeeping at the site.

- 6) The greenbelt and garland drains, especially at the raw material storage yard, shall be adequately developed and maintained. Also, the stormwater management plan and emergency preparedness plan shall be prepared in consultation with the concerned authorities and implemented on a priority basis.
- 7) Housekeeping shall be improved.

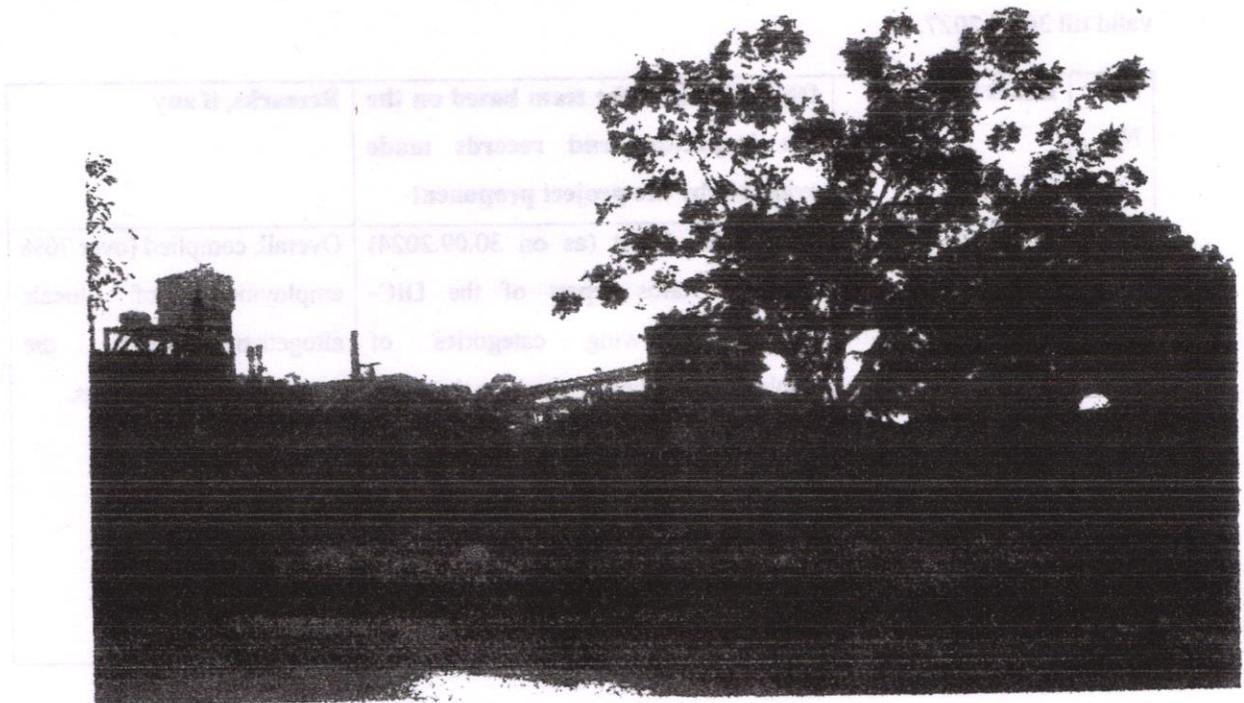
Photo 25. Open material screening area.

- 1) Maintenance of equipment, facilities and infrastructure, including the internal roads on a regular basis is strictly recommended.
- 2) The raw materials shall be stored in sheds or under covered storage, on a stable impervious floor. The industry shall also restrict the heights of the raw material stockpiles to avoid the carryover of fine dust.
- 3) Internal roads to be paved and dedusted regularly by deploying suitable road sweeping equipment.
- 4) The efficiency of the air pollution control devices shall be examined, and the records be maintained for inspection by the KSPCB at any point of time.
- 5) PP shall undertake noise level monitoring in accordance with the prescribed norms and submit reports to the RO-Bengaluru, MoEF&CC (along with the half yearly environmental compliance reports).
